Rail Accident Investigation Branch

Rail Accident Report

**Fatal accident at Gipsy Lane footpath crossing,
Needham Market, Suffolk
24 August 2011**

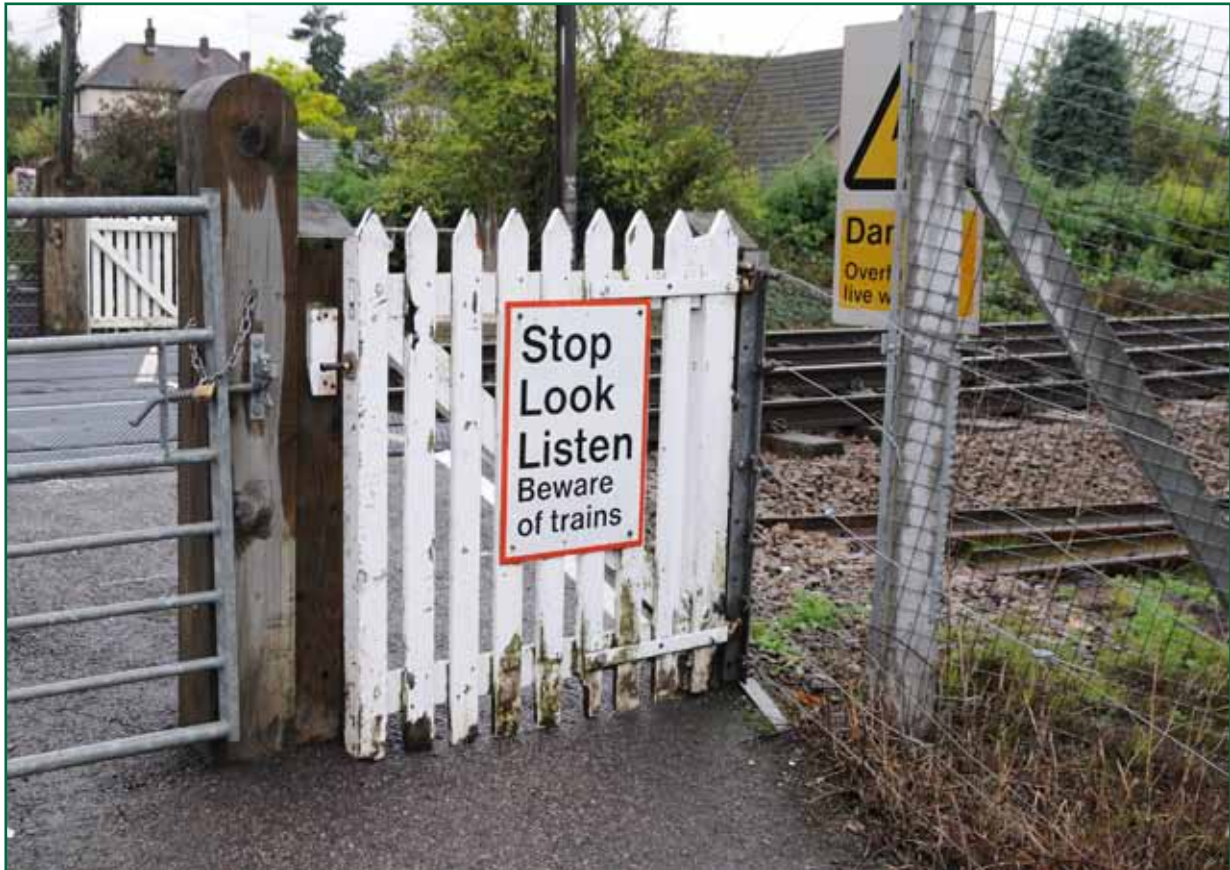
Figure 5: Sign at the crossing gate (view taken from the up side of the crossing - the side from which the pedestrian approached)

- 16 The crossing was fitted with wooden gates on both approaches which opened outwards (ie away from the railway). Signs instructing pedestrians to stop, look, listen and beware of approaching trains were attached to each gate (figure 5).
- 17 The crossing surface comprised rubber panels and asphalt strips. The condition of the crossing surface was not a factor in the accident.

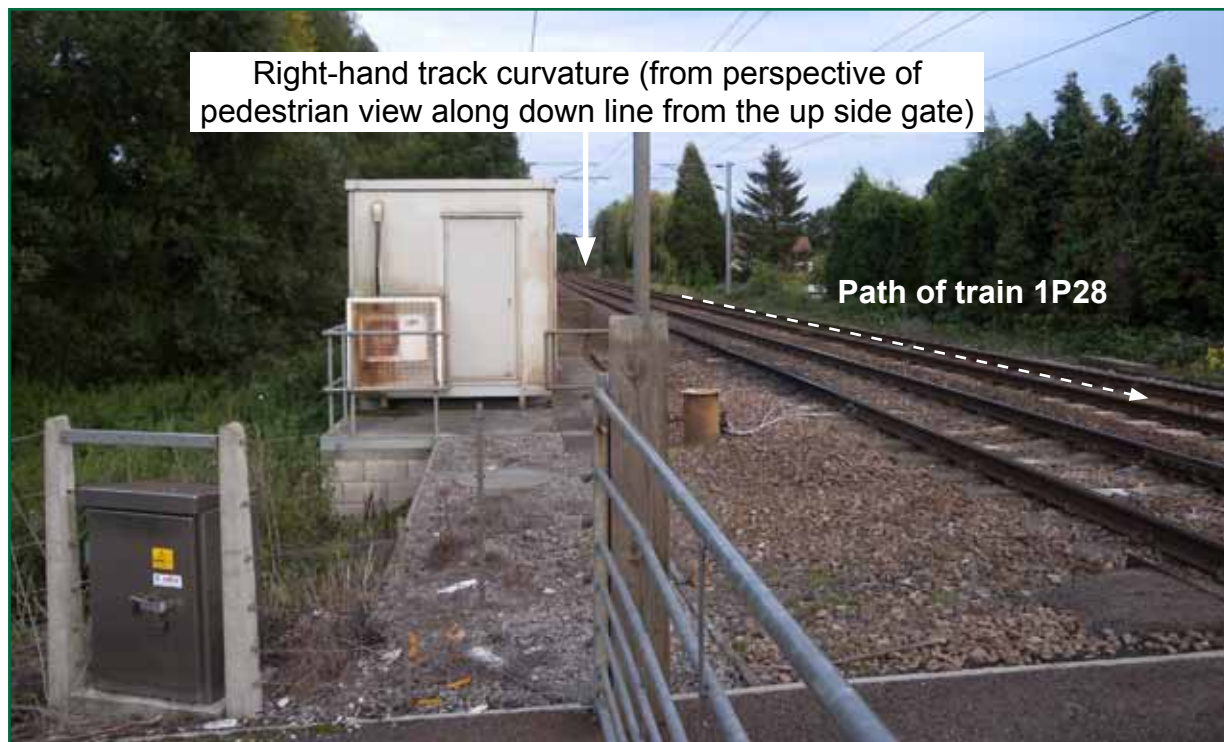
Figure 6: Sighting of down line trains from the up side gate

- 42 The view from the up side gate towards trains approaching on the down line is restricted by line curvature and vegetation. On the day of the accident the *sighting distance*⁹ was recorded as 348 metres using the up side gate as the decision point - see figure 6. In June 2011, Network Rail had assessed that the required sighting distance needed to be a minimum of 448 metres if users were to rely on sighting alone when judging whether it was safe to cross (at this time vulnerable crossing users (see footnote 7) had not been identified and no additional traverse time had been allowed for).

- Required sighting distance on the down line, based on the traverse time and line speed: 448 metres. The available sighting distance at Gipsy Lane footpath crossing was therefore deficient by 58 metres.

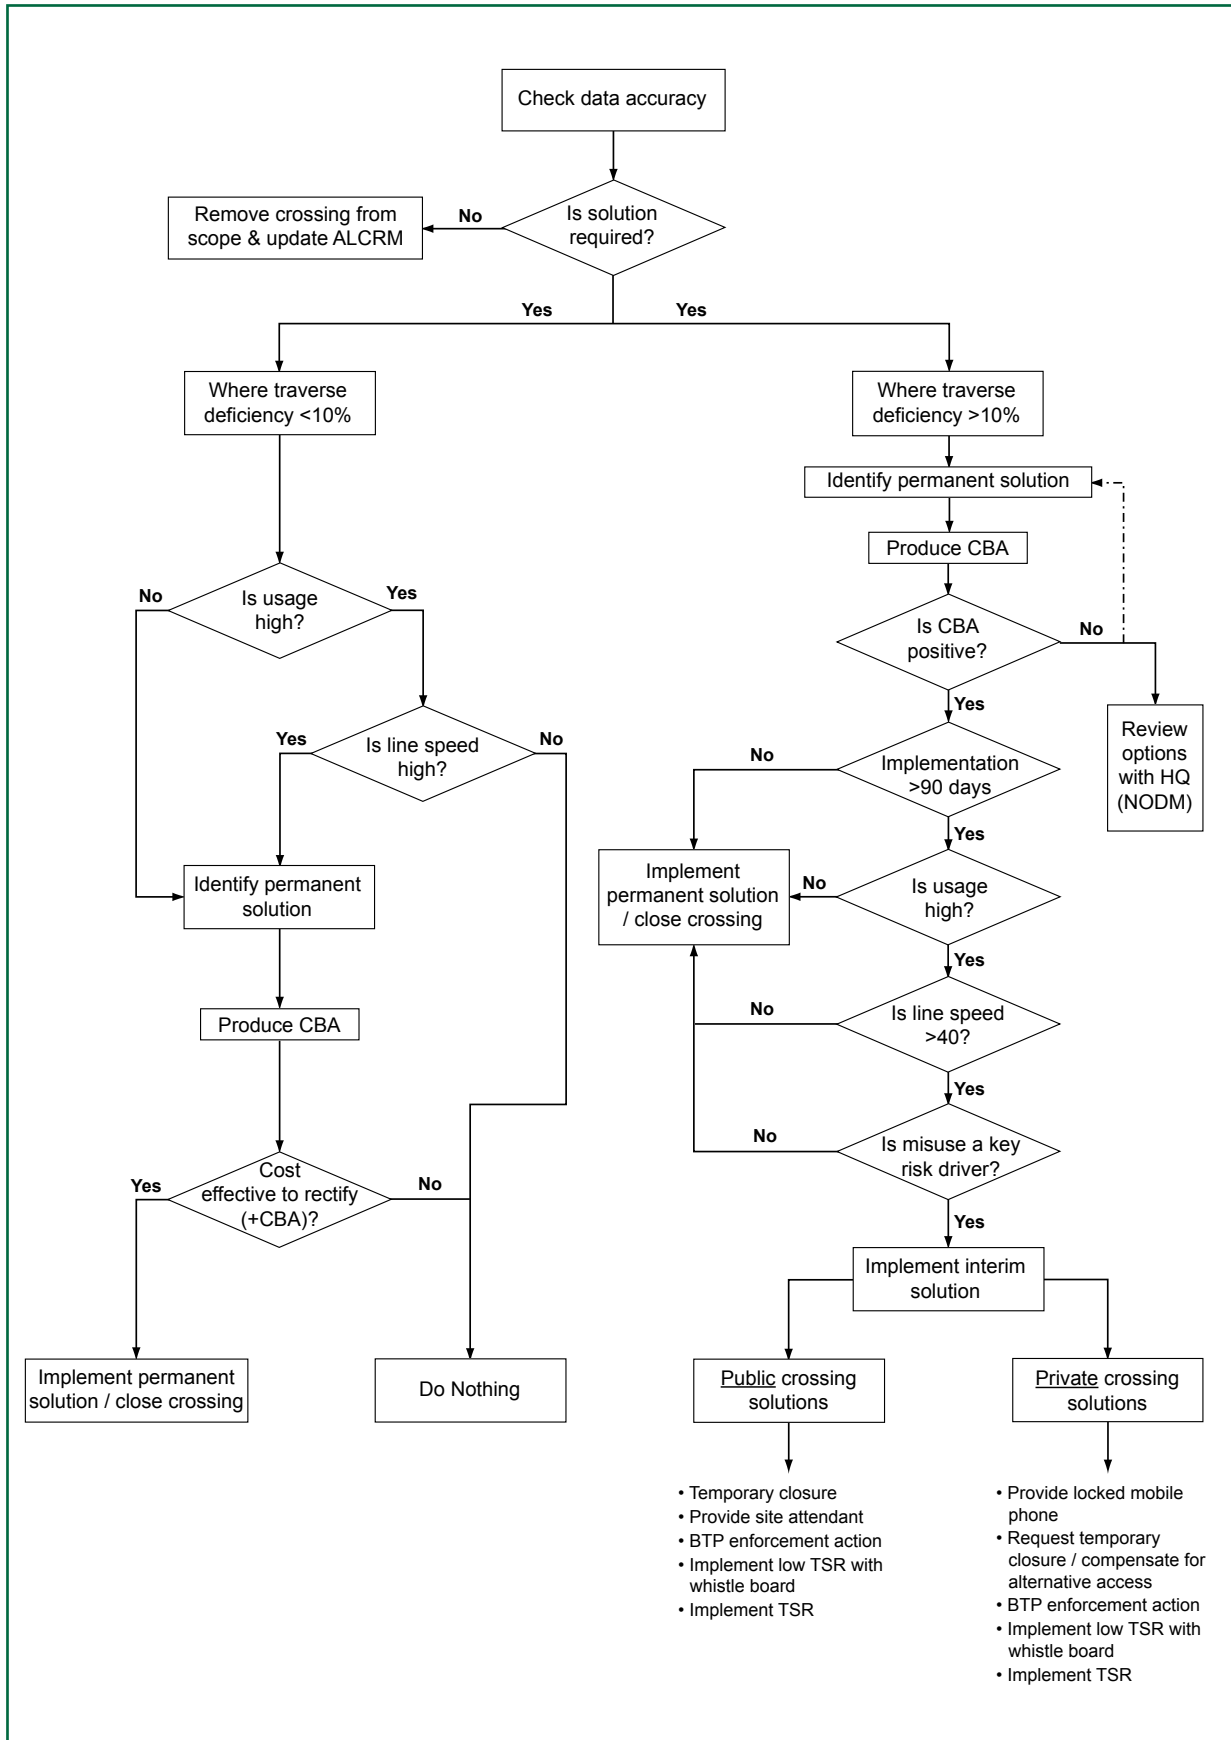
Figure 7: Level crossing decision flowchart devised by the national level crossings team

- Traverse distance: 10.6 metres using the decision point as the up side gate, located 2.7 metres from the nearest rail. The use of this location is consistent with ORR guidance (paragraph 38); the sign indicating how to use the crossing safely was visible at a point where the crossing user could also view trains approaching from either direction.

- 104 The RGM recalled that when the decision flowchart was applied to Gipsy Lane, it did not merit interim mitigation. The crossing had not met the criterion on high usage (figure 6) because the team considered that the June census had shown usage to be low. The quick census at the crossing identified 6 adult users. Using a standard conversion factor the ALCRM calculated that over a 24-hour period 122 pedestrians would use the crossing and that this level of usage was 'large'. However, when the decision flowchart was applied to Gipsy Lane the team defined usage at the crossing as 'low'. Rather than discount interim mitigation at that stage, the assessment was continued, but it was still not possible to reach the 'implement interim decision' box because there was no recent history of misuse at the crossing. For this reason, and for the reasons described at paragraph 96, the RGM stated he did not impose a speed restriction on the down line on the approach to Gipsy Lane footpath crossing.

118 Guidance, in the form of a decision flowchart provided by Network Rail's national level crossings team, sometimes discouraged those involved in level crossing risk management from making short-term changes to reduce risk at crossings such as Gipsy Lane (**paragraph 97, Recommendation 3**).

- 3 *The intent of this recommendation is for Network Rail to develop guidance for use by the level crossing teams on the circumstances under which short-term mitigation measures are to be implemented at level crossings that have insufficient sighting or warning of approaching trains (paragraphs 117d, 117f, 118 and 119d).*
