Rail Accident Investigation Branch

Rail Accident Report

**Fatal accident at Kings Mill No.1 level crossing,
Mansfield, 2 May 2012**

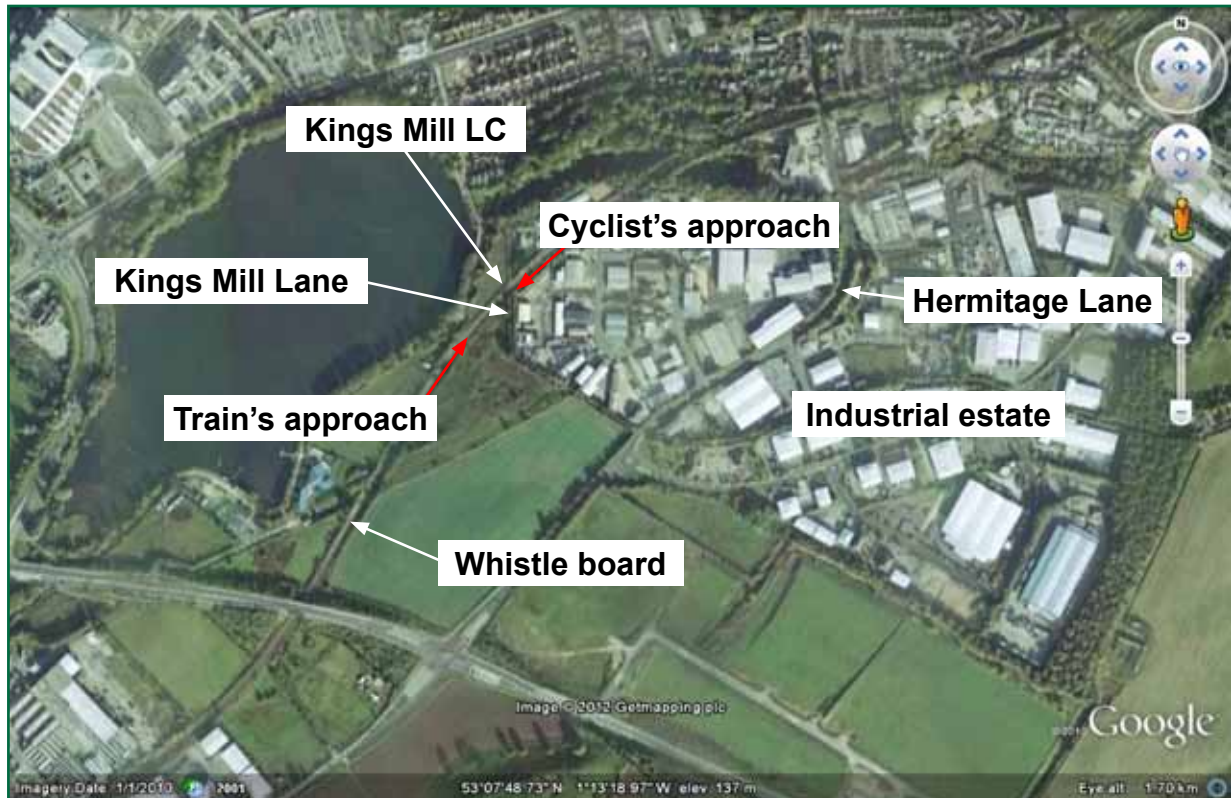
Figure 2: Aerial view of Kings Mill crossing and surrounding area

- 8 The crossing is on the edge of the built-up area of Mansfield: there is open country on the south-west side, housing and light industry on the north-east (figure 2), and a large hospital and a supermarket a short distance to the north-west. A footpath which runs alongside the railway joins Kings Mill Lane immediately south of the crossing.

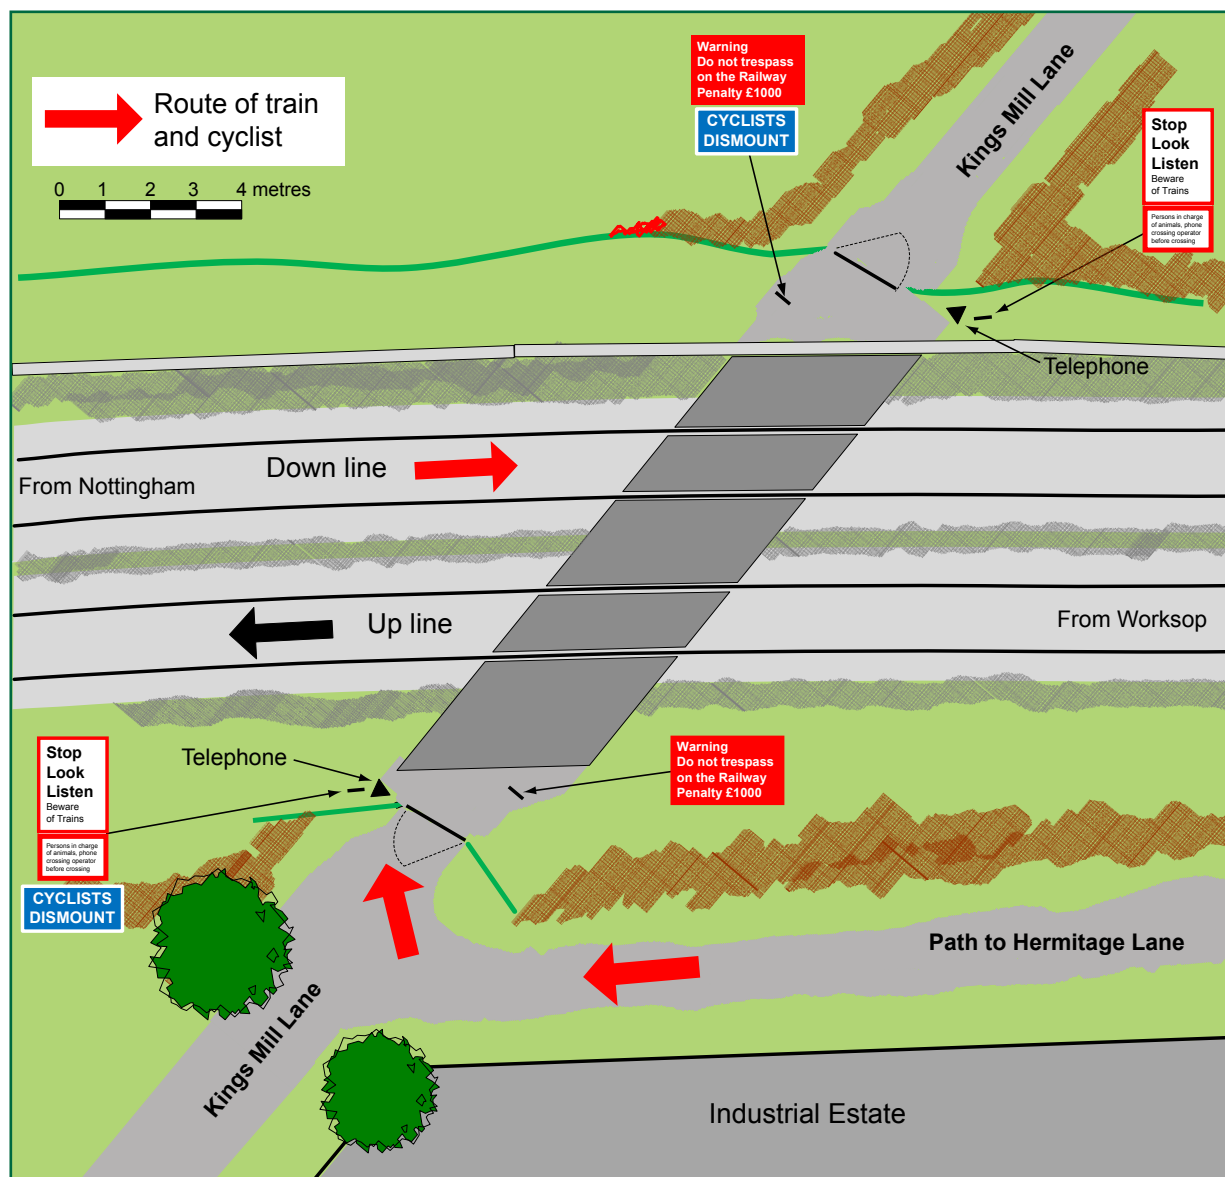
Figure 3: Plan of crossing

- 32 This description relates to the crossing as it was at the time of the accident. It has since been re-aligned to cross the railway at right angles (paragraph 84). There are two approaches to Kings Mill crossing from the up or south-east side of the line. Kings Mill Lane runs almost due north towards the crossing, and another path runs parallel to the railway, behind the industrial estate east of the crossing, and joins the lane immediately south of the crossing.
- 33 The lane crossed the railway at an angle of about 40 degrees.

- 36 At the time of the accident, the crossing was constructed across the railway on the line of Kings Mill Lane, at the angle at which the lane and railway intersect. This increases the length of the crossing deck and the time taken to traverse it, as compared with a crossing at right angles to the line, by about 40%.

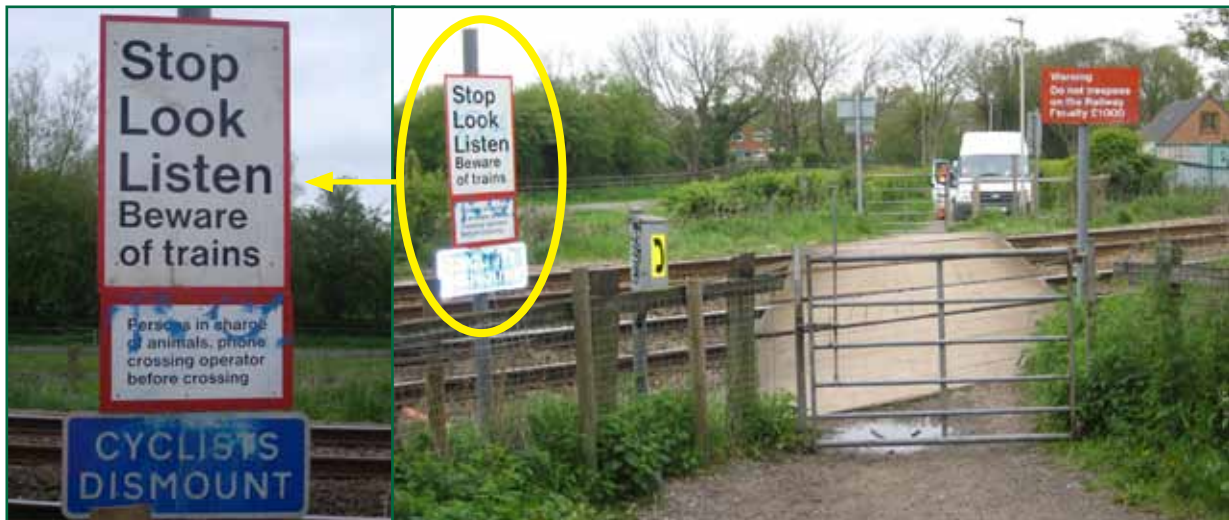
Figure 4: Signs on up side of line

- 34 There were signs to the left of the crossing gate giving instructions on its use (figure 4).
- 35 The sign instructing people in charge of animals to phone the crossing operator is a standard sign at bridleway crossings. The 'Cyclists Dismount' sign was added to the other signs at Kings Mill in 2009 (paragraph 115). The signs and gates, on both sides, are approximately three metres from the nearest rail. This is the position, for this type of crossing, at which a user should be able to make a decision on whether it is safe to cross (see paragraph 66).

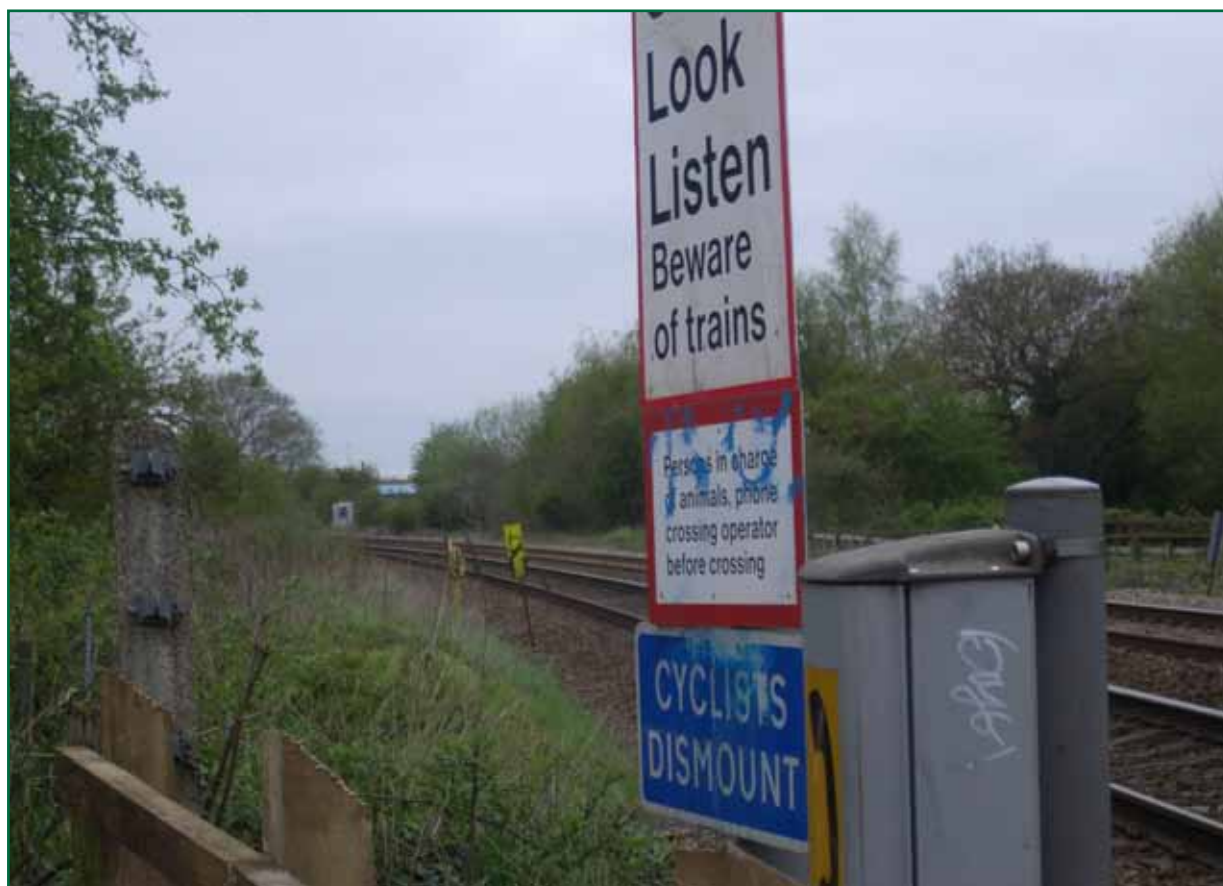
Figure 5: View from up side of crossing looking south-west (towards down trains)

52 The sighting of down trains (those heading towards Mansfield) from the up side at Kings Mill is limited by the curvature of the line.

53 Safe use of Kings Mill crossing relies on the user hearing the warning horn sounded by an approaching train, because the curvature of the line and rising ground combine to obscure the view of trains for people crossing from the up (south-east) side (figure 5).

- 54 The RAIB measured the distance at which an approaching train becomes visible to a person standing at the up side gate at Kings Mill crossing (3 metres from the line) to be 171 metres. A train travelling at 57 mph (92 km/h or 25.5 metres/second) will cover this distance in 6.7 seconds. The forward facing CCTV shows that Mr Dawn was struck by the train approximately five seconds after he started to cross the line. The curvature of the line means that there is little increase in the available sighting of down trains as a user moves closer to the track.
- 55 If Mr Dawn looked up the line while he was opening the gate, he would not have been able to see the approaching train until less than two seconds before he started across the line, at which time he was likely to have been concentrating on manoeuvring his bicycle round the gate and onto the crossing.
