Rail Accident Investigation Branch

Rail Accident Report

**Fatal accident at Gipsy Lane footpath crossing,
Needham Market, Suffolk
24 August 2011**

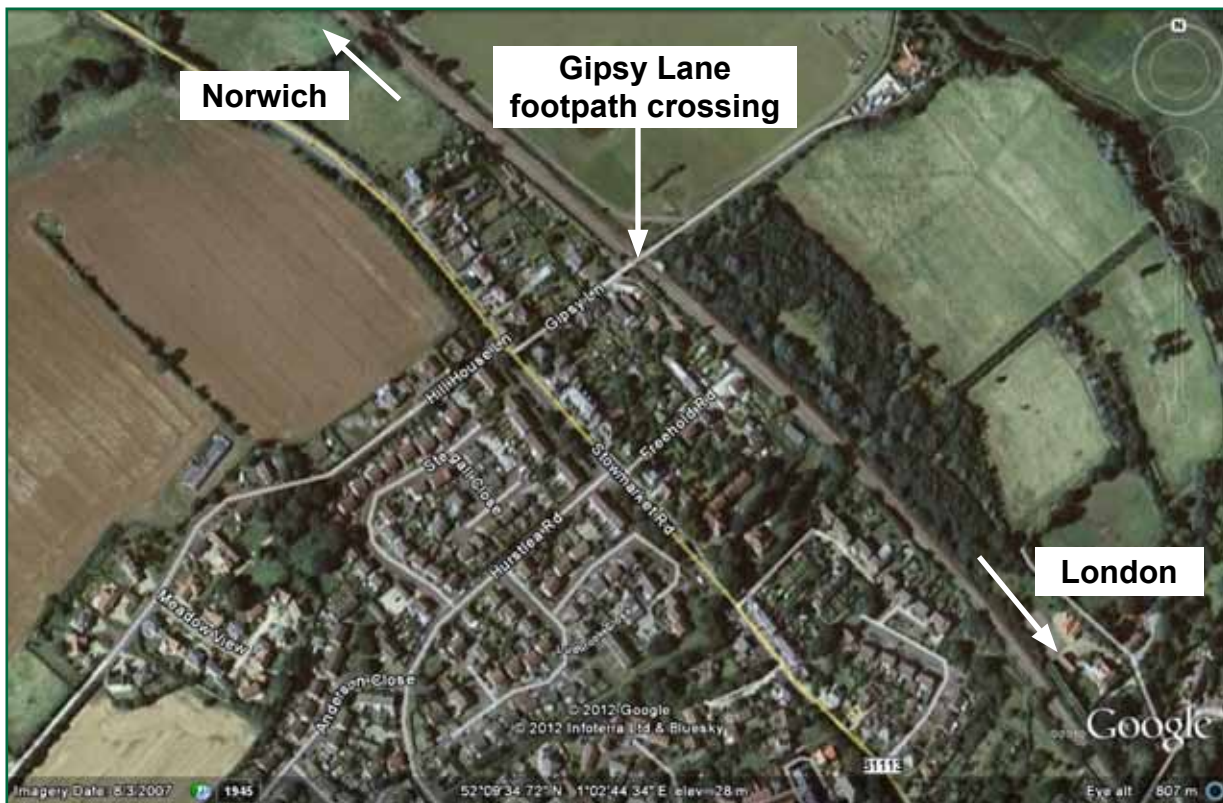
Figure 2: Overview of Gipsy Lane footpath crossing and its immediate surroundings (courtesy of Google Earth)

- 8 Gipsy Lane footpath crossing is located at 77 miles 64 chains¹ from London Liverpool Street station, on the northern outskirts of Needham Market, Suffolk. A residential area is located on one side of the crossing, and farmland on the other (figure 2).
- 9 The general layout of the crossing and key dimensions are given in figure 3. There are two railway tracks at the crossing and the maximum permitted speed for trains travelling in either direction is 100 mph (161 km/h).

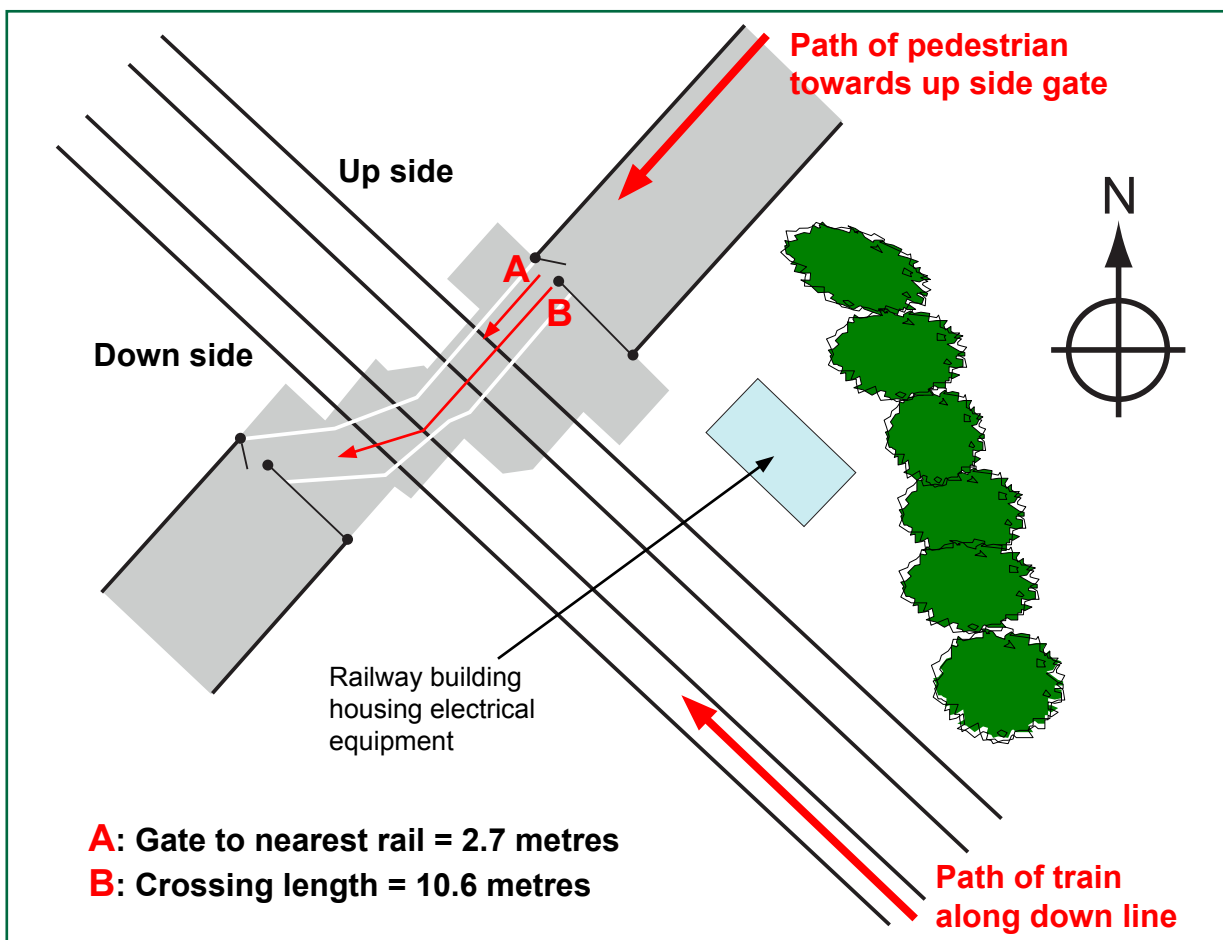
Figure 3: Layout of Gipsy Lane footpath crossing

- 10 Pedestrians have a restricted view of trains approaching along the down line (ie from the London direction) due to line curvature and seasonal vegetation growth. For this reason, a *whistle board* is provided to warn pedestrians of an approaching down train. This is located 396 metres from the crossing.

- 40 The pedestrian who was struck was crossing from the up side gate to the down side. The train was travelling on the down line (figure 3).
- 41 A sign is provided on the up side gate, which instructs users to stop, look, listen and beware of trains. Measurements taken at the crossing recorded that the gate and sign were positioned 2.7 metres from the nearest rail (figure 5).

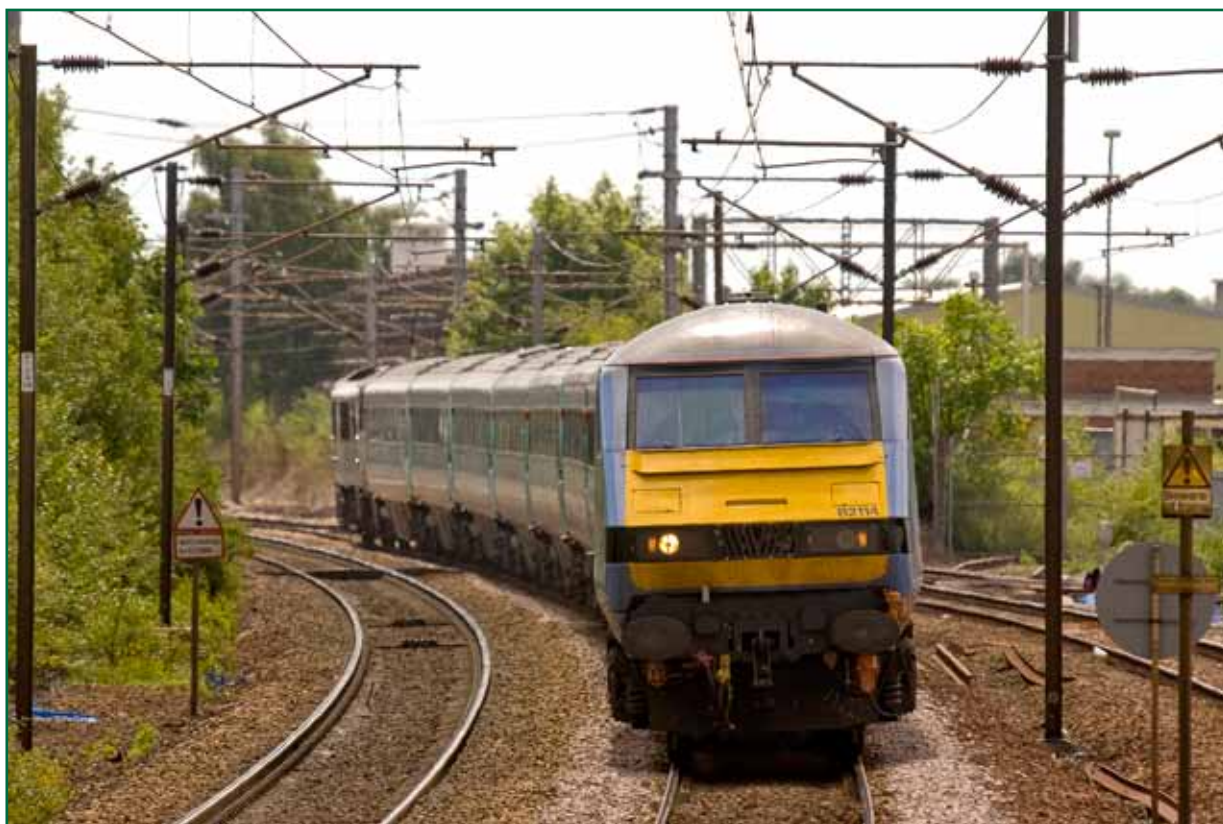
Figure 4: A DVT leading a train formed of Mark 3 coaching stock. A class 90 locomotive is attached at the rear of the formation (not the train involved or the location of accident) (image courtesy of Kev Gregory/Railway Herald)

- 14 Train 1P28 was formed of a *Driving Van Trailer (DVT)* leading a *rake* of ten Mark 3 coaches being powered by a class 90 locomotive attached to the rear of the train (figure 4).
- 15 The RAIB found no evidence to link the condition of the train with the cause of the accident.
